San Jacinto River Waste Pits Superfund Site USACE Support

San Jacinto River Waste Pits

USACE Support

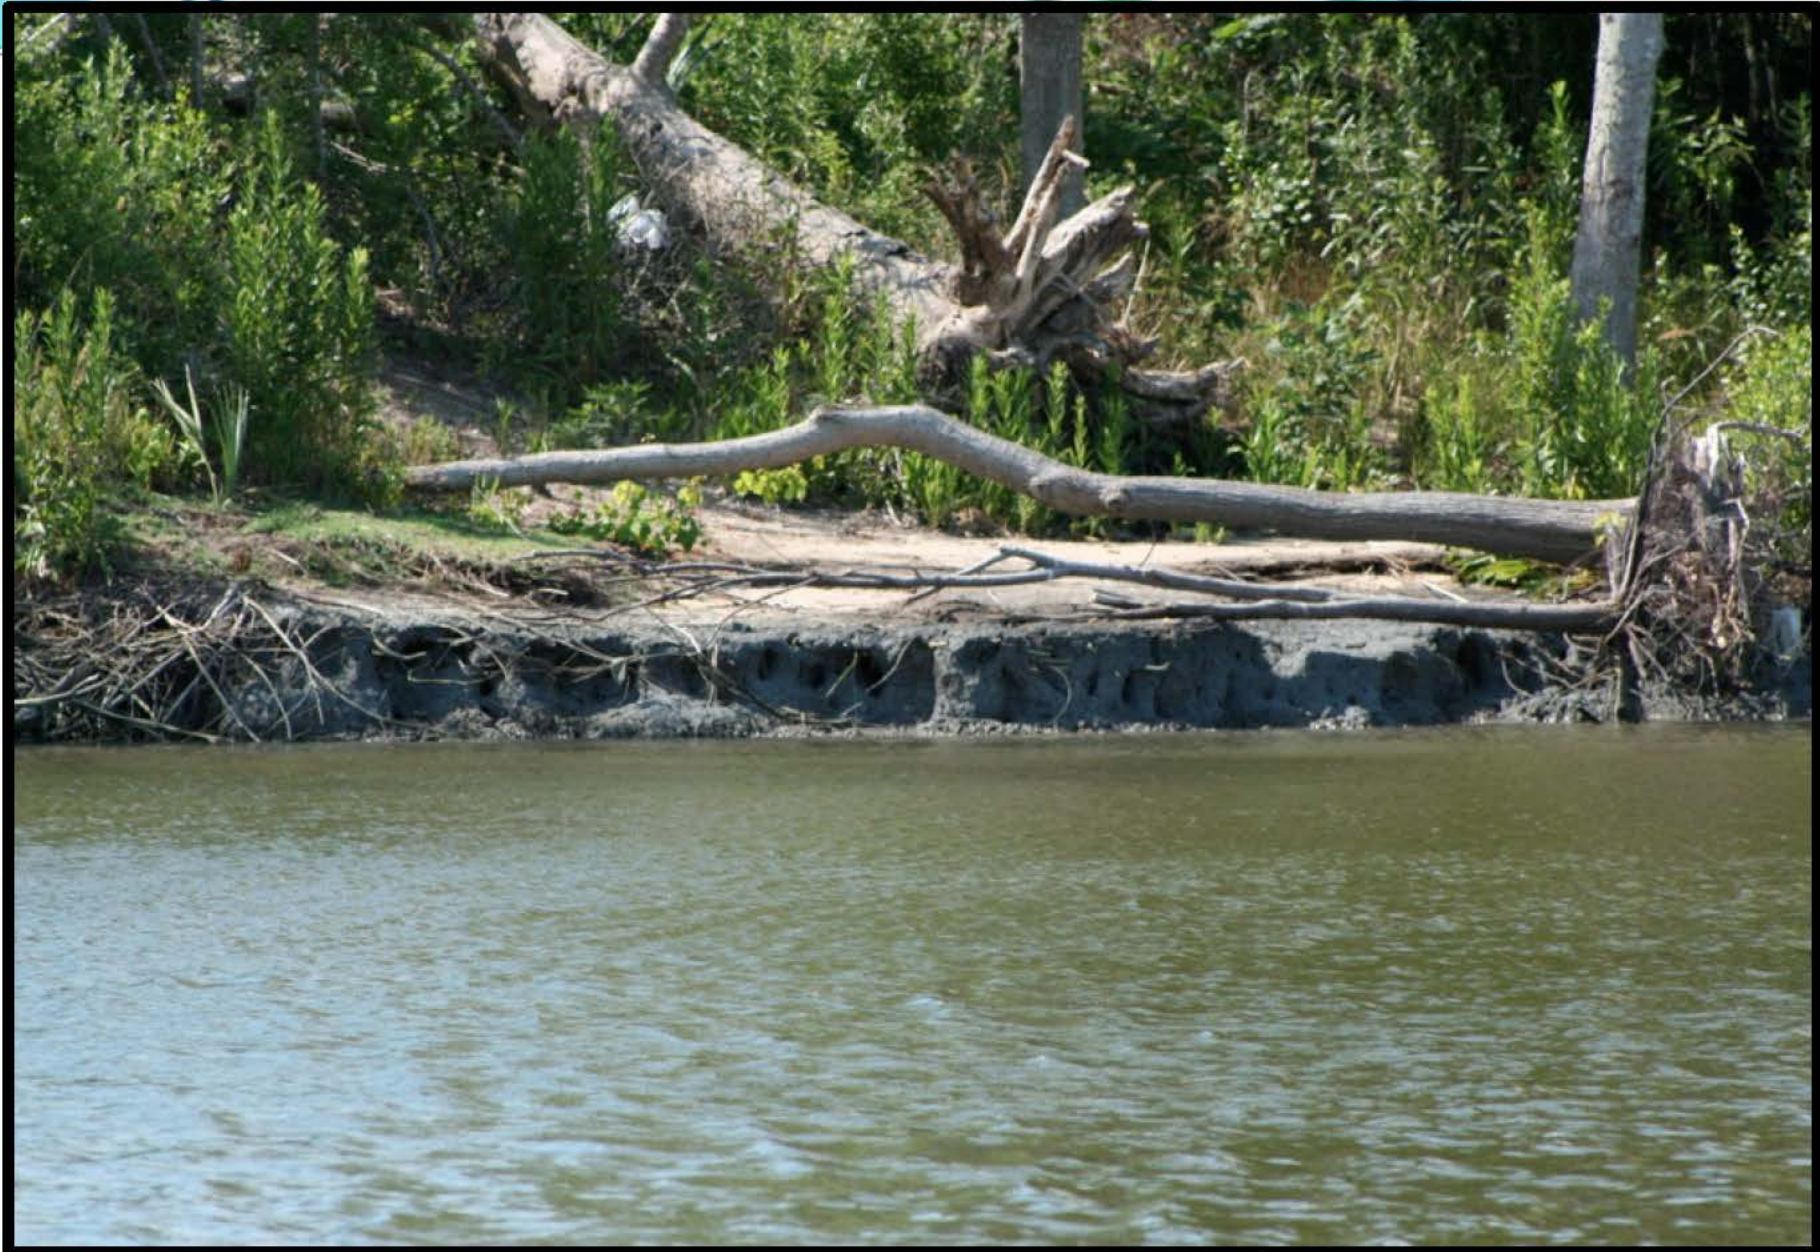
**South
Impoundment
1965**

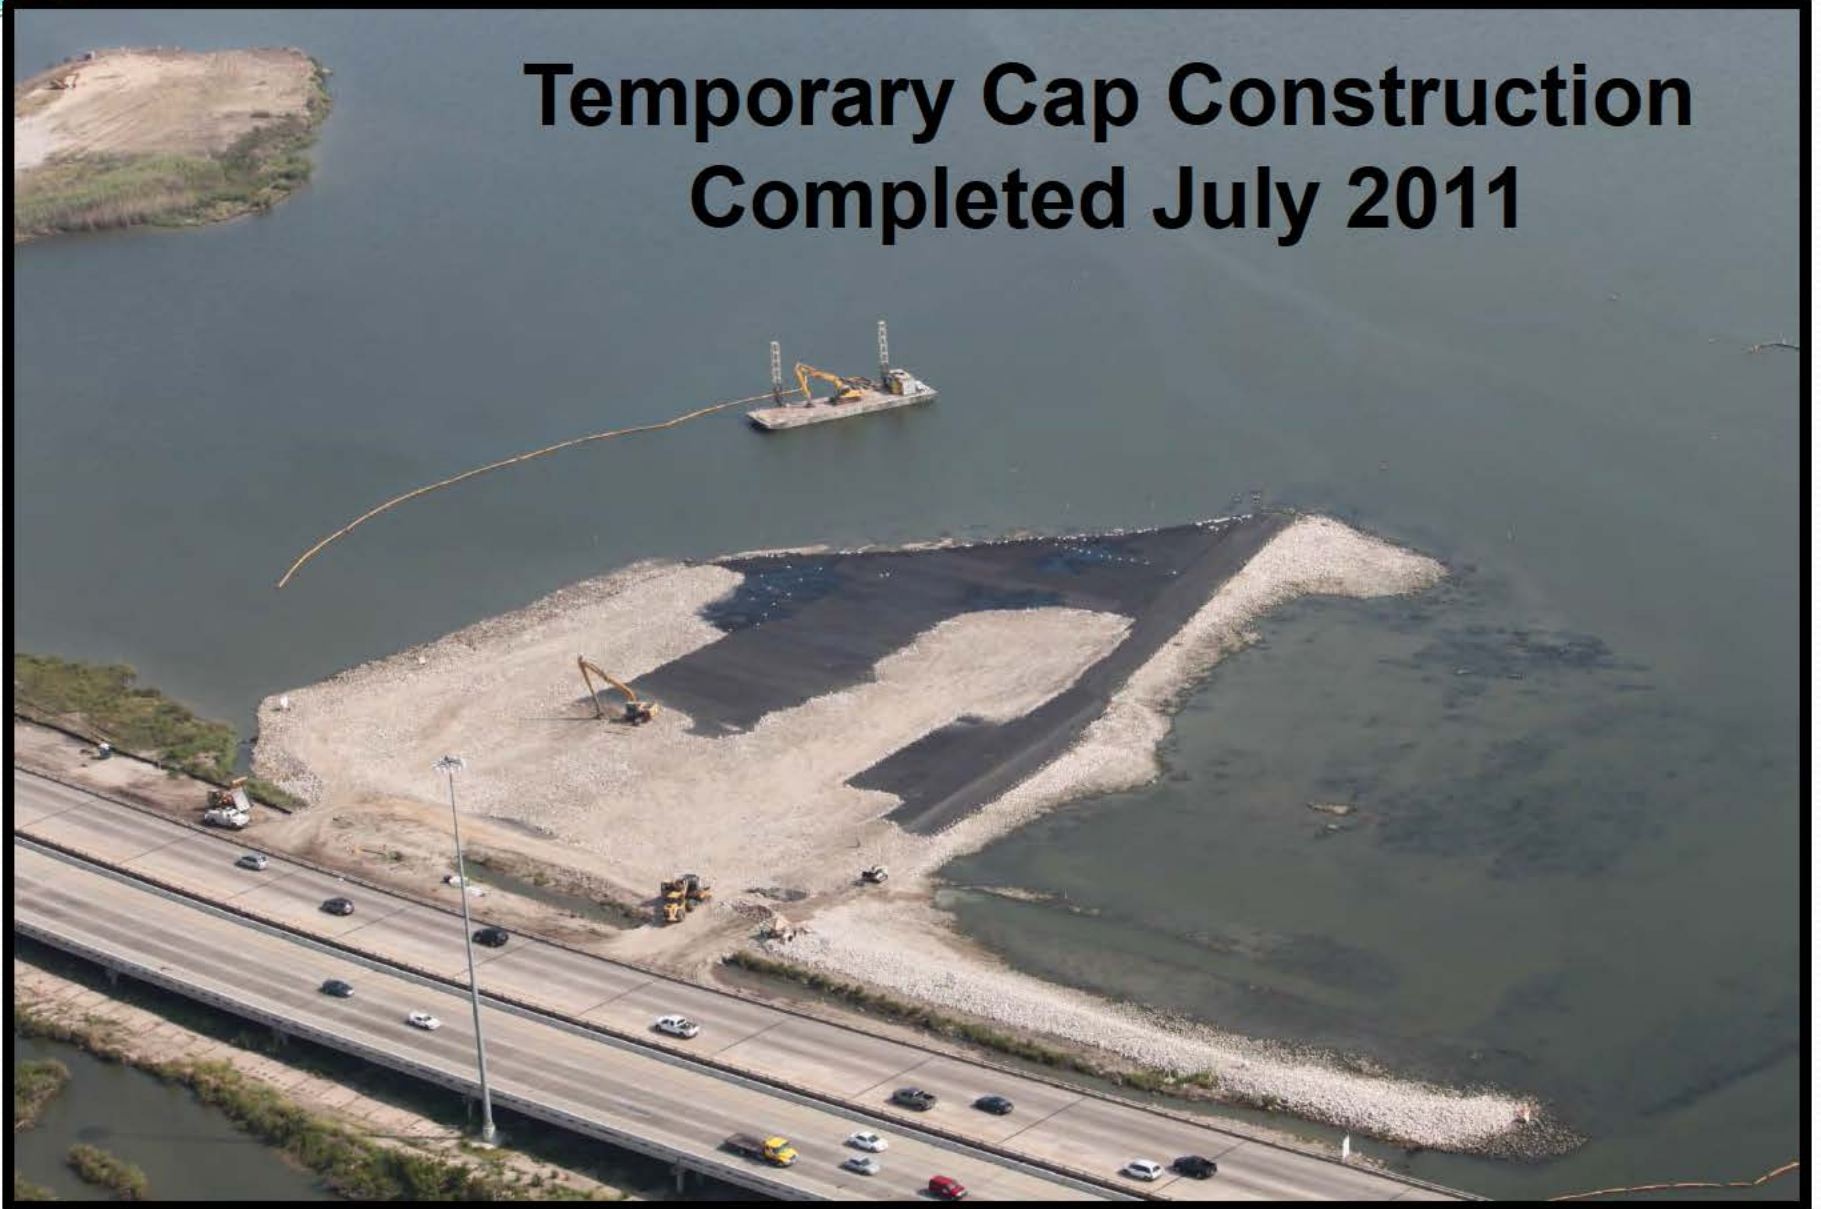
Temporary Cap Construction Completed July 2011

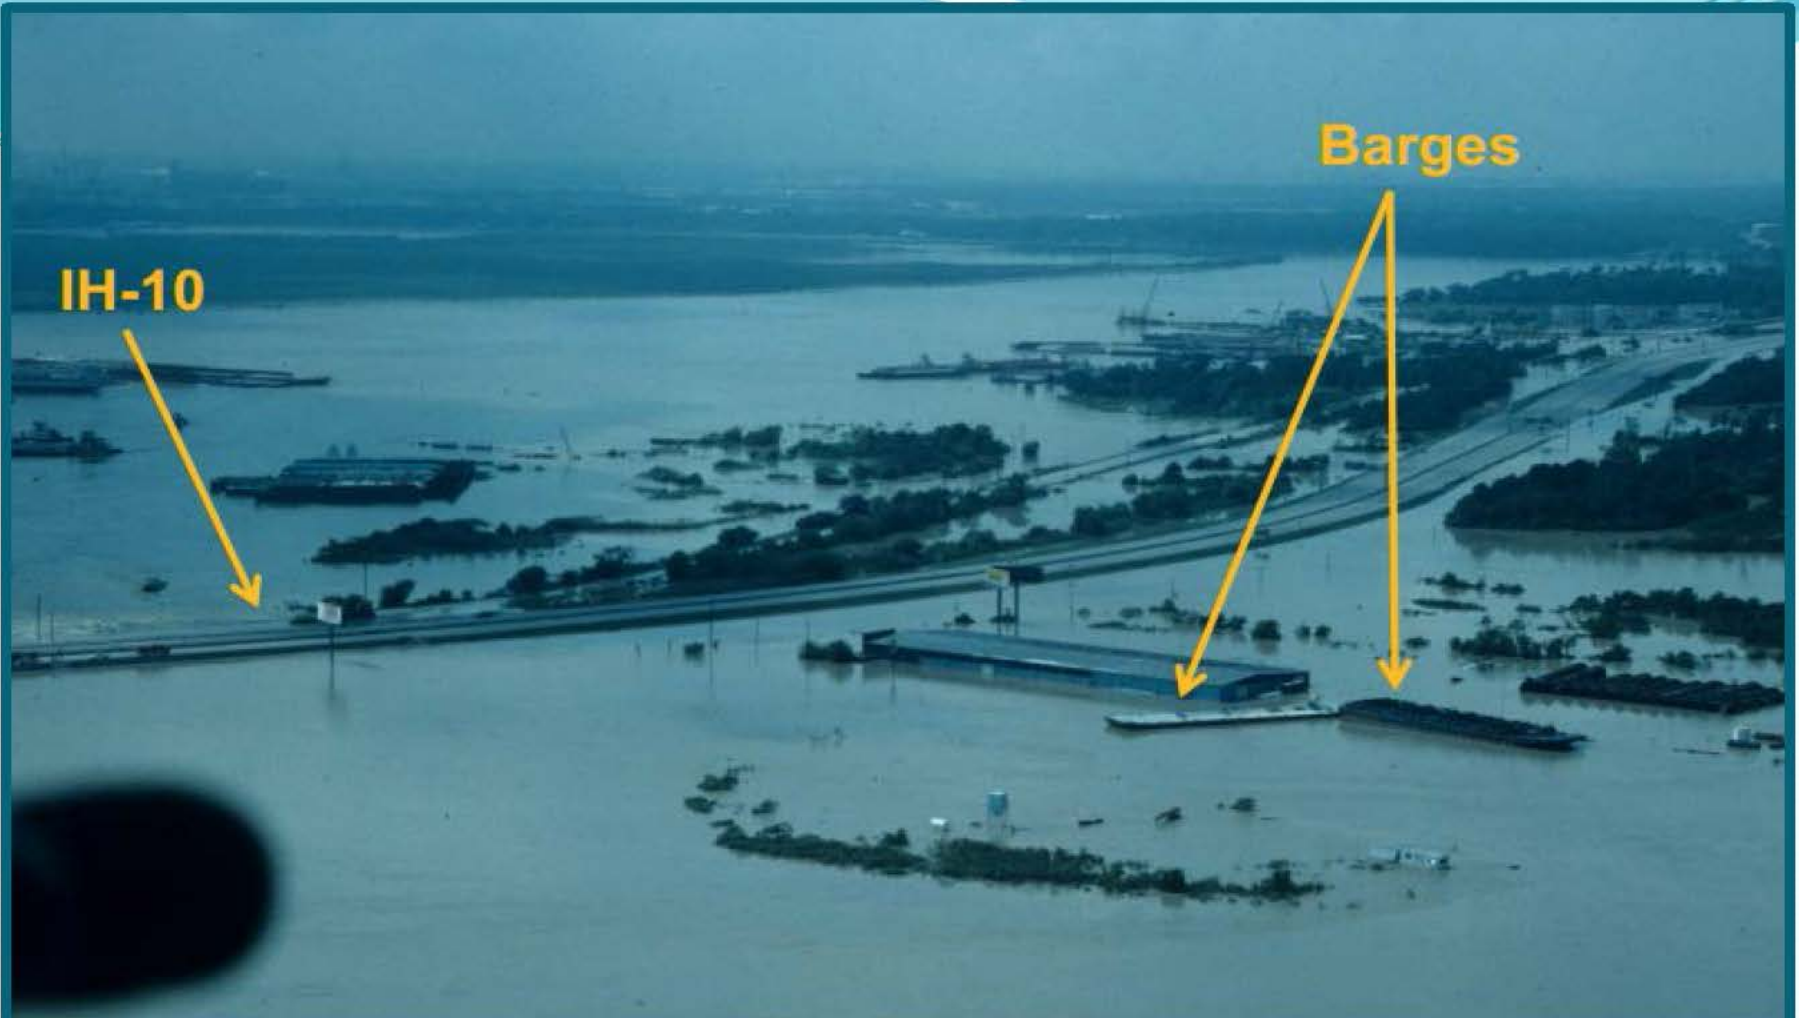
Lower San Jacinto River

San Jacinto River at I-10 (Photo: HCFCD)

- Upper Texas coast recorded 25 hurricanes, 7 of which were major (Category 3 to 5) storms.
- October 1994 storm greater than 100-year flood (1.6 times):
 - Major soil erosion – 8 pipelines ruptured & 29 undermined; 3000 homes destroyed.
 - 10 to 12-feet of bed scour south of the I-10.

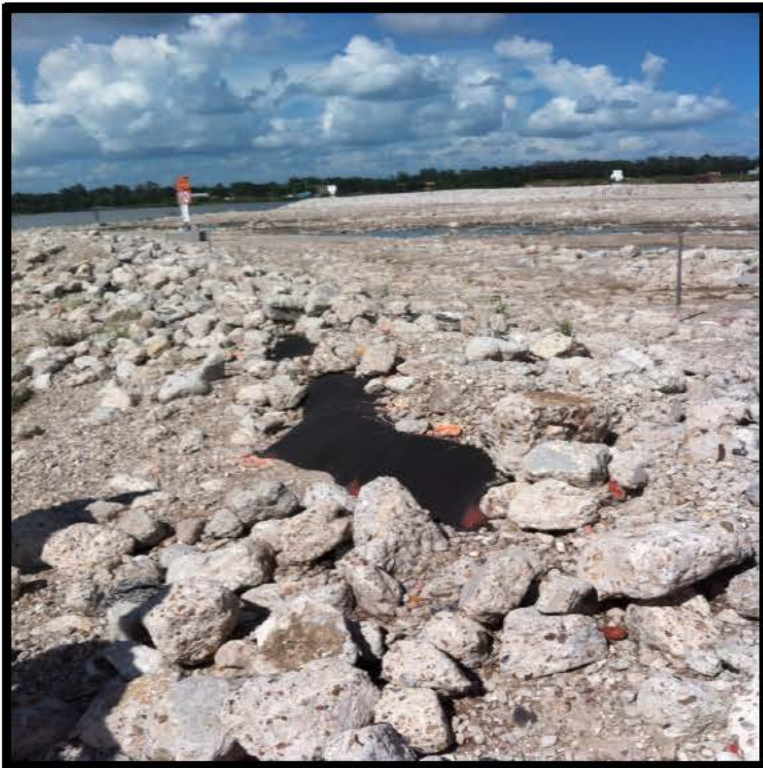
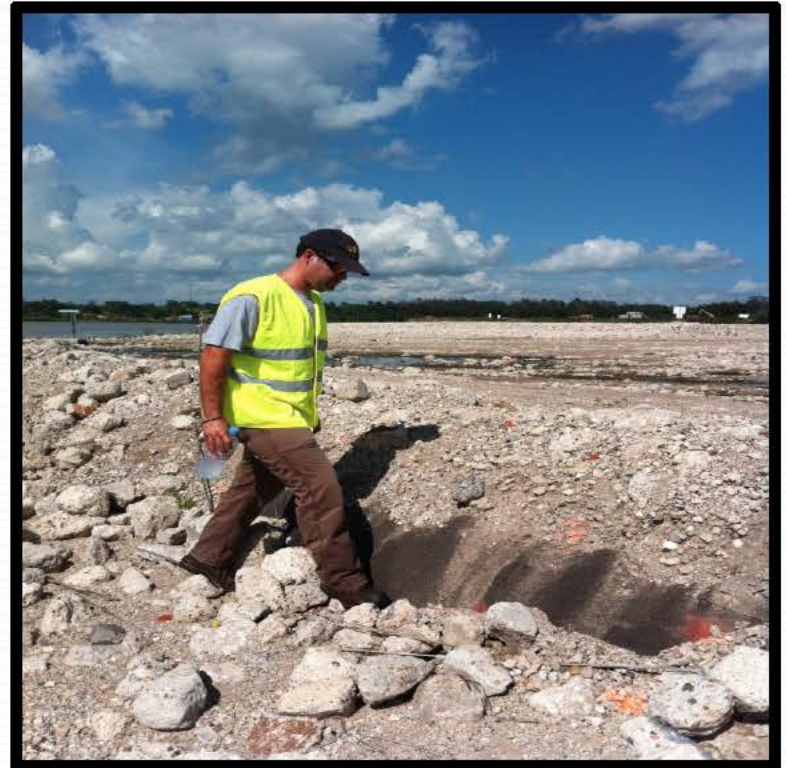
Temporary Cap – Berm Erosion

- Western Berm erosion July 2012.
- Completion of repairs August 2012.
